FINAL ACCIDENT INVESTIGATION REPORT

A5-BHT (EC130 T2 / H130, MSN:8160)

WACHEY- LUNANA, GASA, BHUTAN

03 MARCH 2023

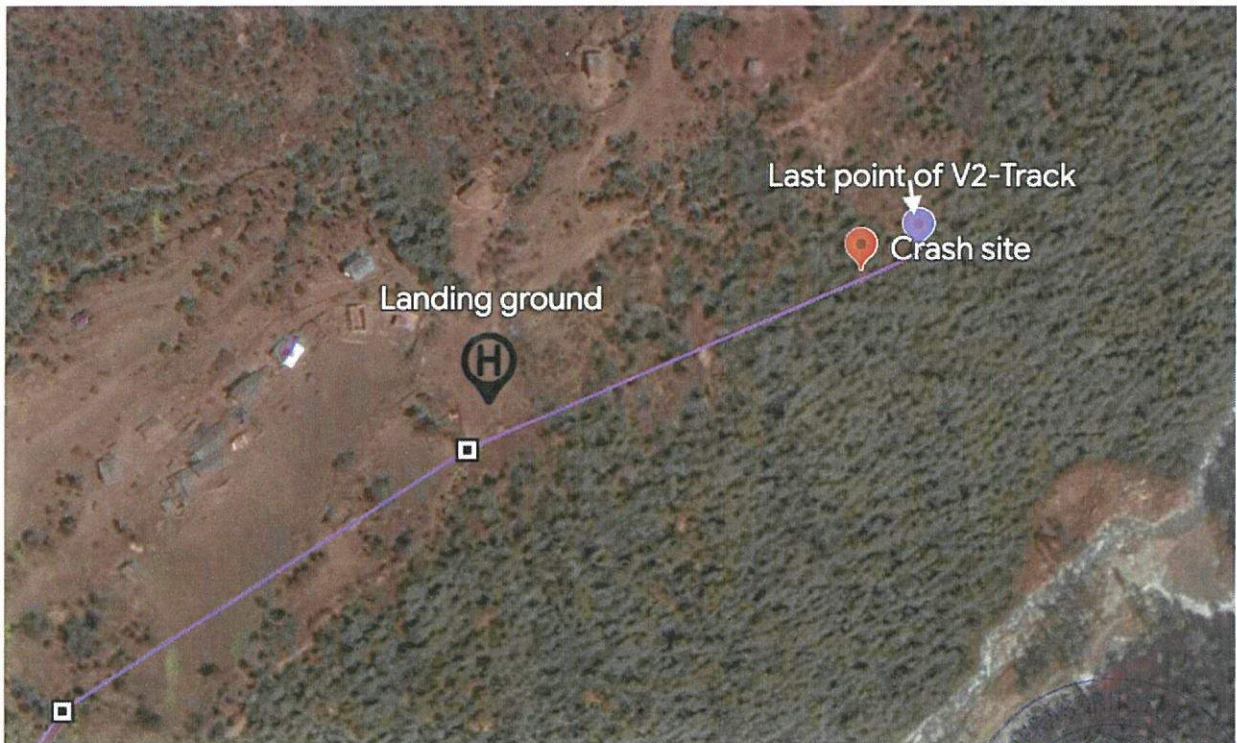
Fig 1: Helicopter crash site at Wachey, Lunana.

The Helicopter was on its short final approach at Wachey when it crashed about 200 meters north-east of the landing site at nearby ridge of coordinate N28°00'34" E089°59'53" at an altitude of about 3880 meters above mean sea level (AMSL). At the crash site, the helicopter was destroyed with two fatalities and three survivors.

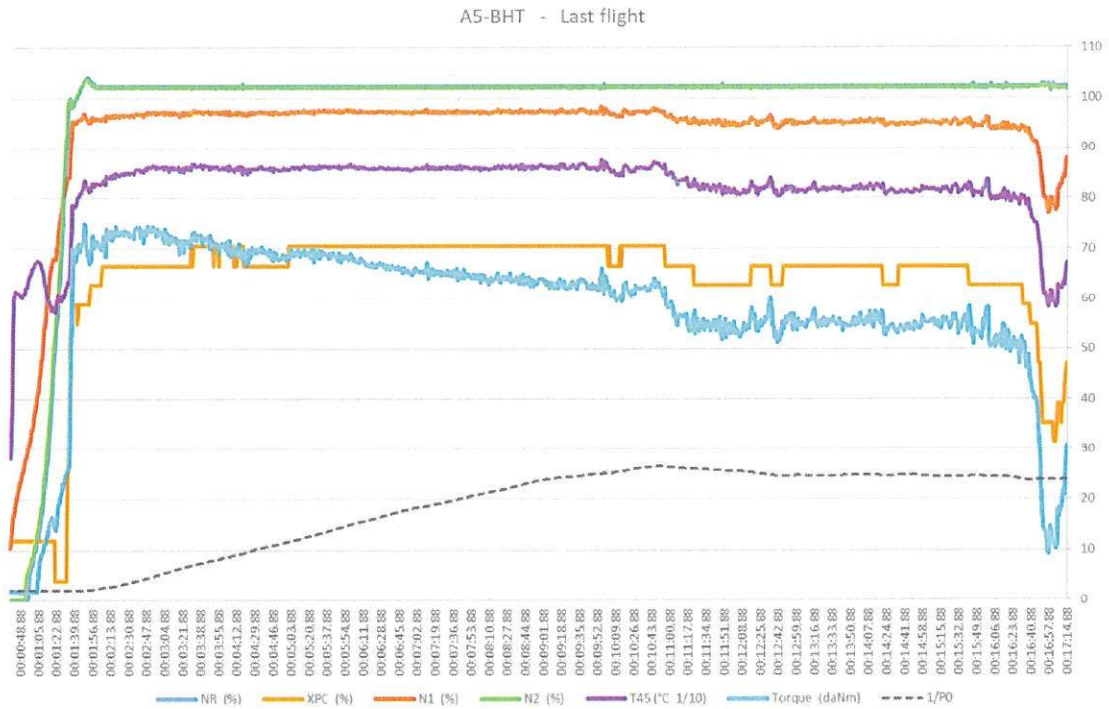
Fig 5. EDR Continuous recording (Safran)

The graph depicted above shows the continuous recording of EDR recorded in the Channel A (graph from channel B was quasi-identical). The time indicated in the graph corresponds to the EDR time, which may differ from the actual flight time. The continuous recording contains about 17 minutes 15 seconds of recording after the ECU power on, and approximately 16 minutes 35 seconds of flying time.

The “1/P0” value gives an indication of the variation in aircraft altitude. There was no caution recorded during this recording.

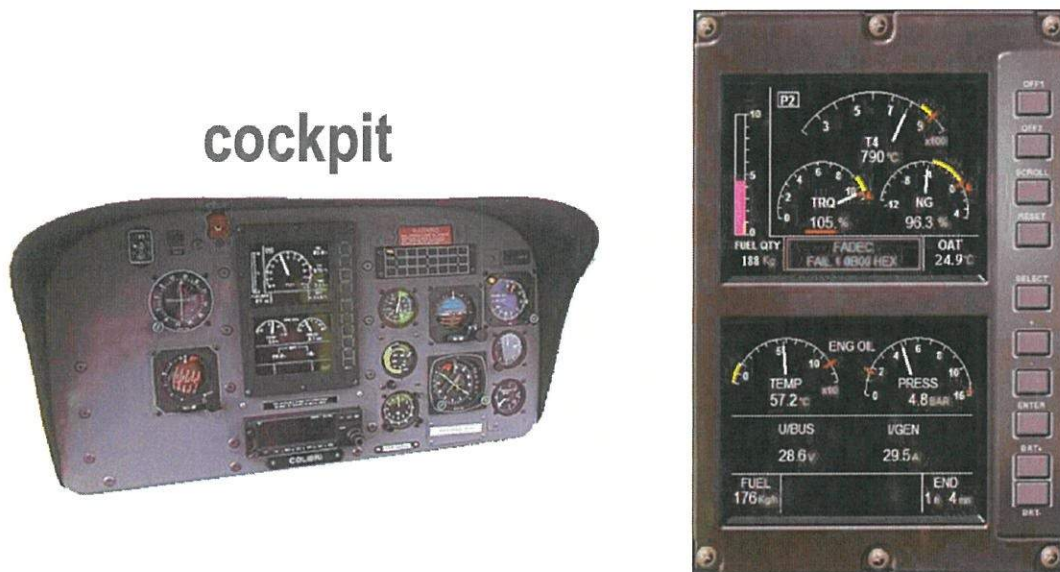
Fig 10. VEMD (BEA)

The VEMD was visually examined and found damaged. It was crushed on the back and the top of the casing. The screen was in good condition. Since EDR data was fully recovered, no further work was performed on the VEMD as it wouldn't bring anymore insights for the investigation.

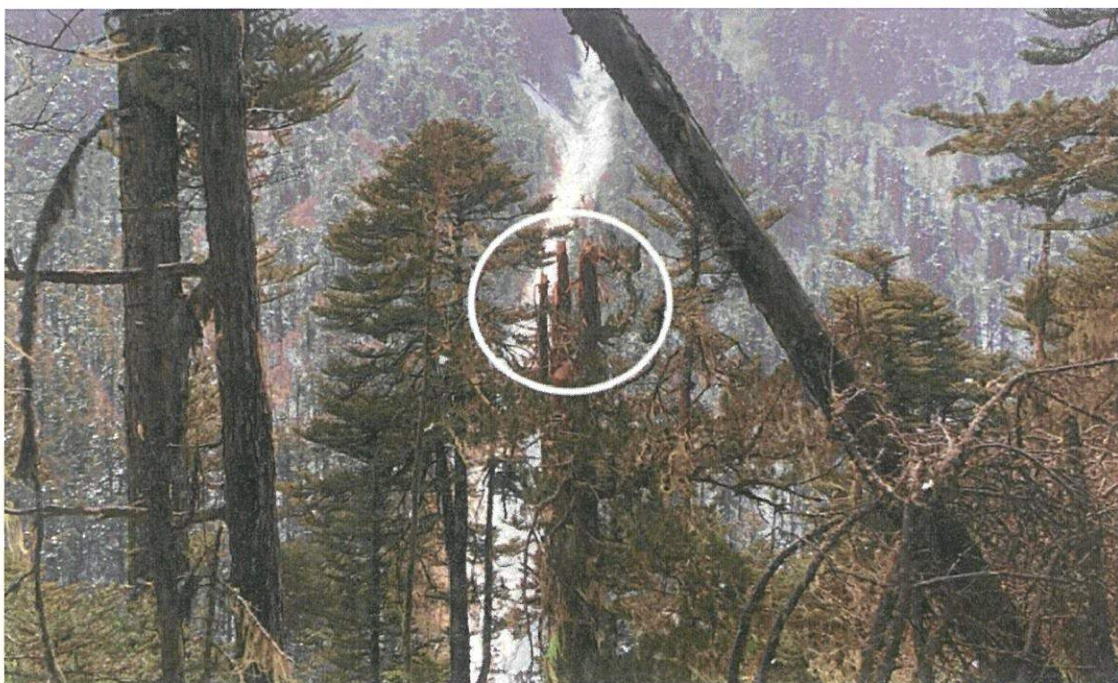
Fig 11. First probable impact of the helicopter

The wreckage was found at the base of two trees with the tail boom separated from the main body and a broken piece of one of the main rotor blades was found about 3 meters above. The main wreckage was located at the base of two trees, with right side of the skid buried in the ground while the left was being wedged against the tree trunk. There were few traces of fuel leakage near the fuel port but no traces of fire. The front windshield sustained complete damage, and the main impact was taken by the main rotor blades and the tail boom, which got separated from the main body. There was no evidence of pre-impact failure or detachment. All the damages to the structure and main rotor blades are consistent with the impact with the trees and the ground.

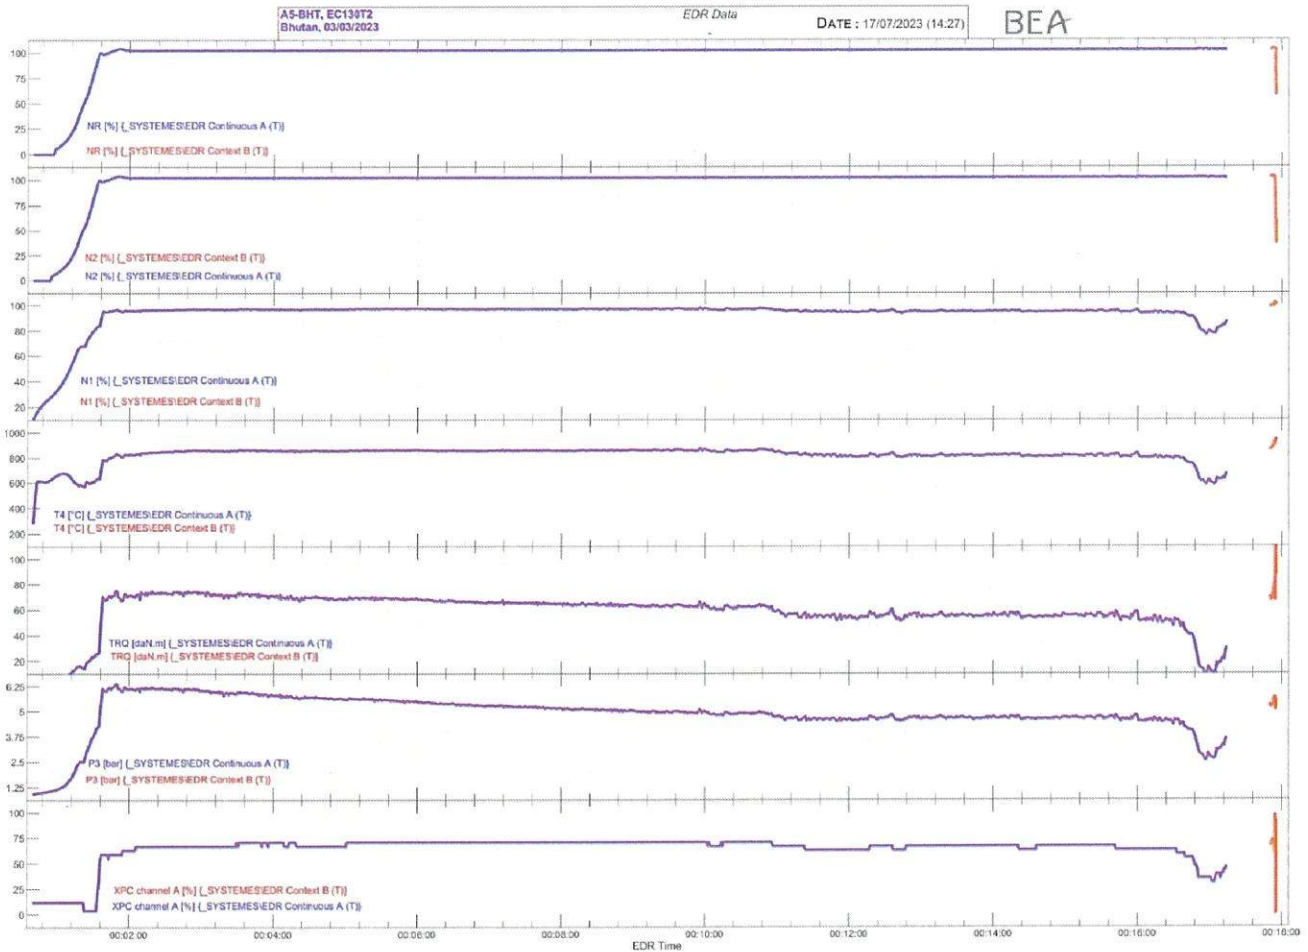
Fig 14. EDR complete flight (BEA)

The continuous recording contains 17 minutes 15 seconds of recording since the ECU power on. Throughout the continuous recording period, all the engine parameters were nominal and evolved in good synchronicity with the pilot's power demands. The main rotor (NR) speed remained quasi-constant at the nominal value and it suggests that the engine was delivering the power required during the flight. No discrepancies concerning the engine and its control systems were observed during the flight.

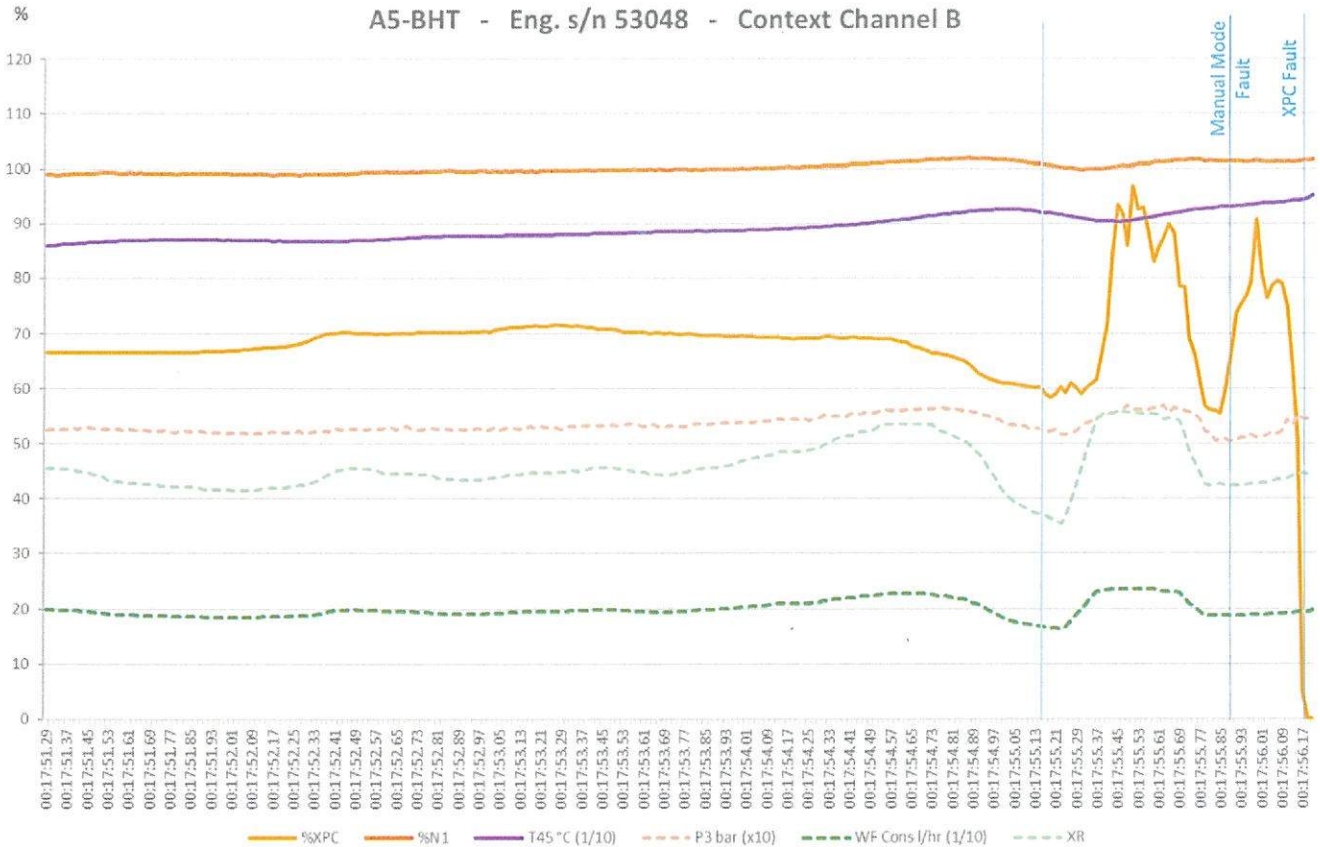
Fig 16. Context recording (Safran)

The channel B contained 5 seconds of context data which was analysed. The continuous recording stopped at 17 minutes 15 seconds (EDR time) and the context recording started from 17 minutes 51 seconds and stopped at 17 min 56 seconds. There is a gap of 36 seconds which are missing between the continuous recording and the context recording. The ECU sends the continuous recording every minute to the EDR for recording and the missing 36 seconds is consistent with the recording logic of the EDR.

All the engine parameters including the engine's fuel flow target (WF Cons) were nominal until the last 1.5 seconds of the recording. The turbine speed (N2) and main rotor speed (NR) reduced to about 48 % within 0.7 seconds during the final 1.5 seconds of the recording. Torque overlimit (reached a value of 138 daNm) was recorded at around 17 minutes 56 seconds and also collective pitch measurement (XPC) fault was noted within the last 1.5 seconds of the recording.

During the first 3.5 seconds there was a good synchronicity between the pilot's power demand (collective lever signal XPC) and the engine's fuel flow target (WF cons). There were variations in the fuel flow (WF cons) as well as fuel control system's actuator (XR) in the last 1.5 seconds of the recording, which led to fuel flow changes in the combustion chamber as seen in the combustion chamber pressure (P3) and the turbine temperature (T45). The fuel

flow parameters appeared erratic in the last 1.5 seconds of the recording, as it was likely that the engine control system was not able to keep up with the rapidly changing aircraft attitudes during the crash sequence.

All the overlimits and discrepancies within the last 1.5 seconds were probably due to the consequence of the crash sequence. There were no faults and anomalies recorded throughout the entire flight except for the last 1.5 seconds of the recording. The failure of the collective pitch anticipator potentiometer (XPC) occurred most probably as a result of impact with the trees or ground. The helicopter was on the ground (or at least on the trees) when it recorded the torque overlimit and other overlimits in the final 1.5 seconds of the recording.

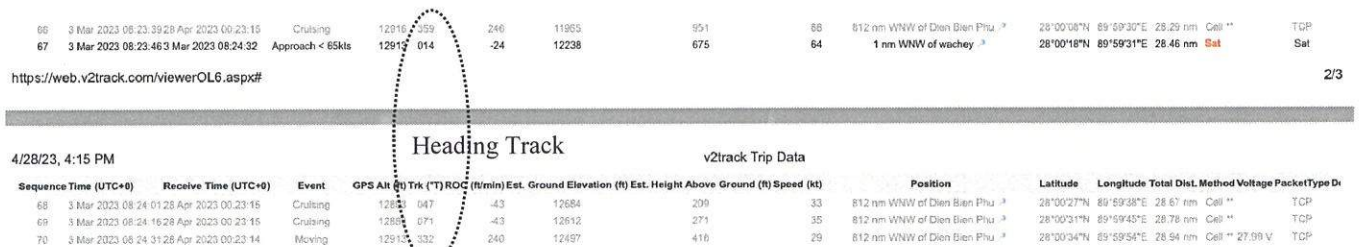
Fig 17. Accident flight trip profile (V2-Track)

The V2-Track trip profile indicates that the approach speed was about 65 knots and the rate of descend (ROD) during the approach was from 24 - 43 ft/min. The ROD is minimal which ties in with the low approach seen by the witnesses. During the approach, the heading change was from 359° at 08:23:39 (UTC) to 071° at 08:24:16 which was followed by sudden heading change from 071° to 332° within 15 seconds (99 degree heading change within 15 seconds). This corroborates with the witness account of helicopter's approach from Southwest to Northeast before making a steep left turn. The V2-track registered a climb during the left turn which seems to tie with the increase in collective.

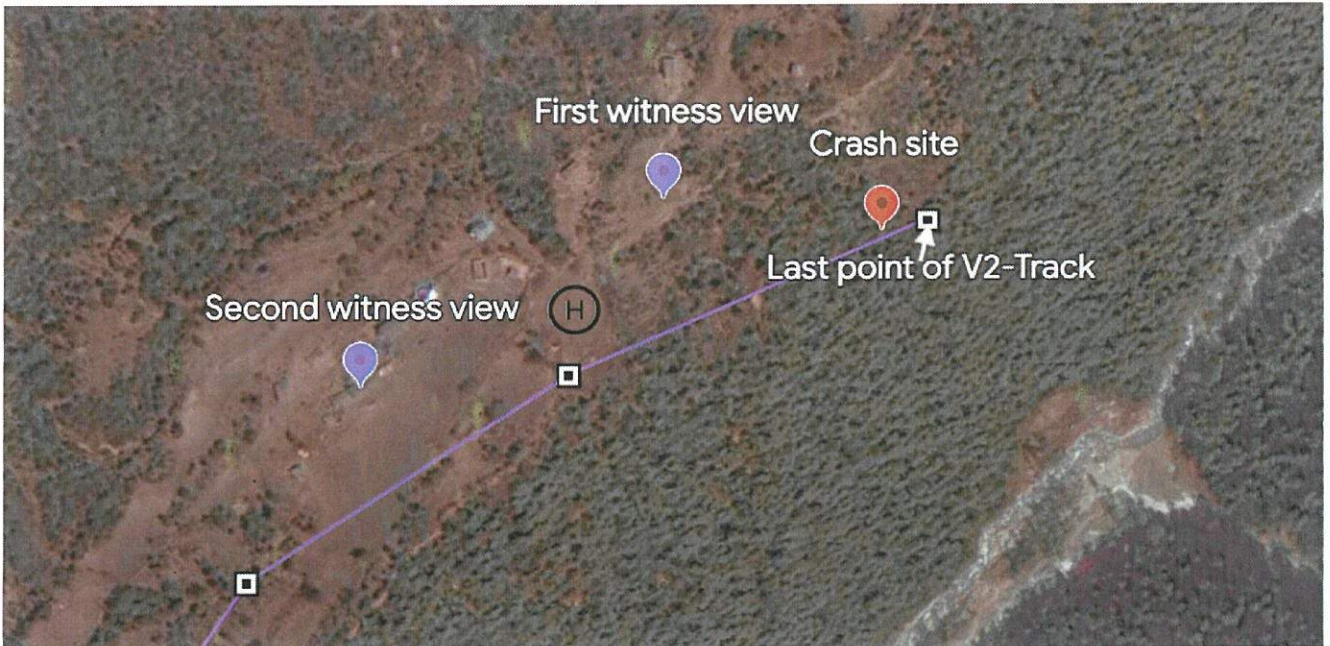
Fig 18. Crash site and V2-Tracker

A total of 13 missing data points has been recovered. There were no anomalies observed regarding the V2-Track flight trajectory. The flight path of the helicopter has been recovered until few seconds before the crash as seen from the last point of the V2-Track.
