# Environmental Monitoring Report

Project No: 42173-017  
Semi-Annual Report (January – June 2024)  
October 2024

## Bhutan: Water Flagship Program Support Project

Prepared by the Project Management Unit, Water Flagship Program Support Project, Ministry of Infrastructure and Transport, Royal Government of Bhutan for the Asian Development Bank (ADB).

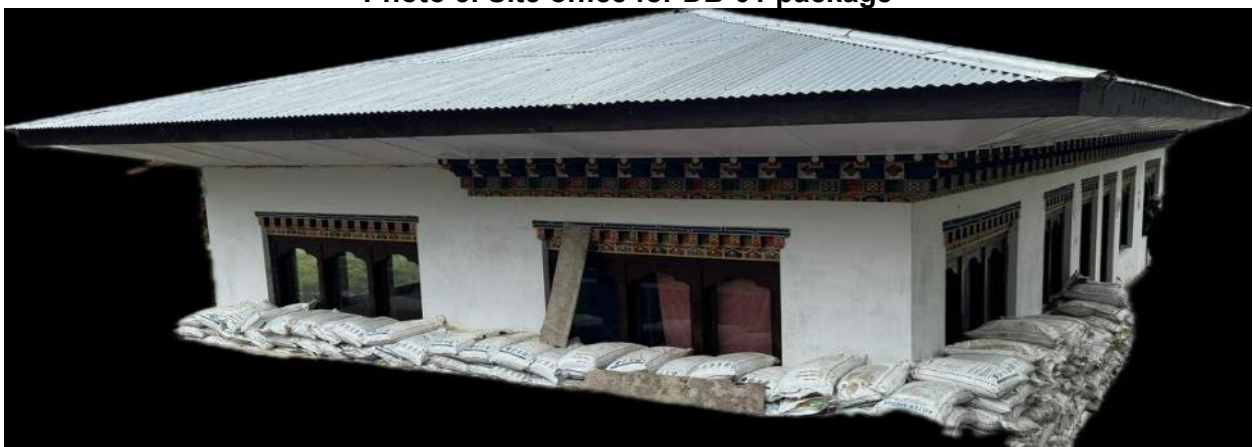
**Photo 3. Site office for DB-01 package**

27. Office, Material and machinery storage are all located within the WTP premises.

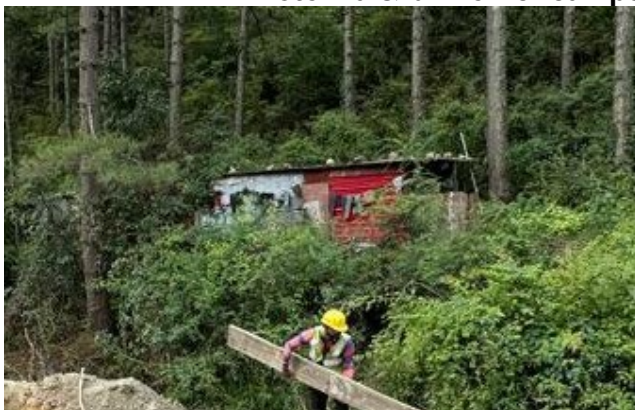
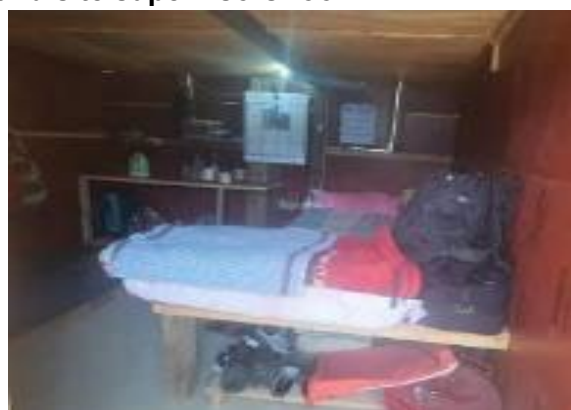
**Photo 4 a & b. Worker camps and site supervisors room**

31. Within the site, camps workers have been constructed. The camp houses 4 workers in each room. The temporary site office has been demolished to give way for the construction of desilting and settler tank. The office space has been shifted to the newly constructed building some 120m near the existing staff quarter of the existing 1MLD Dechencholing LAP WTP.
32. Electricity and sanitation facilities (with septic tanks) have also been provided. The electrical fixtures have been safely installed. No trees were cut to construct worker camps.

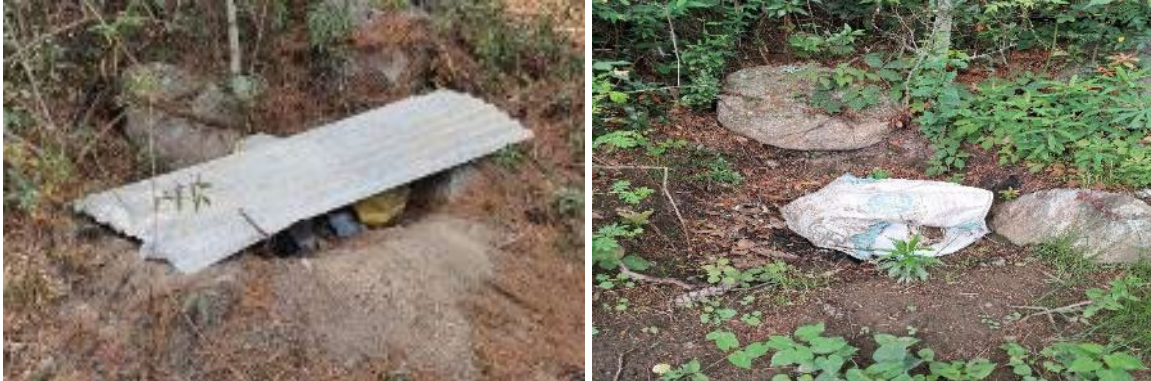
**Photo 7 a - Waste pit and 7 b - waste littering issue resolved**

35. Waste is gathered in a covered pit at the WTP site and sorted into biodegradable and non-biodegradable wastes. The non-biodegradable waste is taken to the Dangrina waste drop off center, situated less than a kilometer away, while the biodegradable waste is deposited into the pit. The recent problem of littering that was reported in the last reporting period has been rectified.

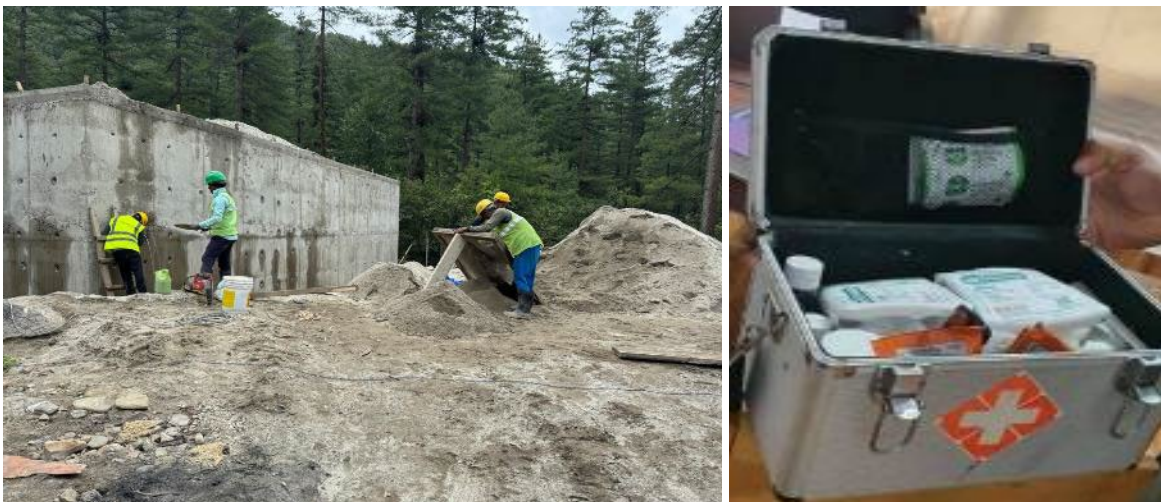
**Photo 8 a& b. - Use of PPE and first aid kit at site**

36. The contractor has prepared and submitted the Health and Safety Plan including a COVID-19 plan to the Thromde which has been approved. In terms of OHS, the following measures are in place.

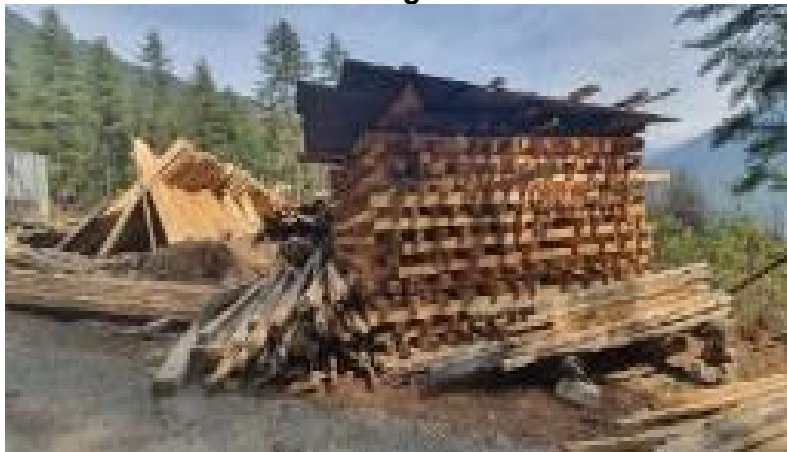
**Photo 9 - Cut trees being seasoned and stored.**

42. With the forestry permit, 33 trees in DB-01 WTP site have been cut. The contractor has paid the required royalty and retained the cut trees for their construction purpose.

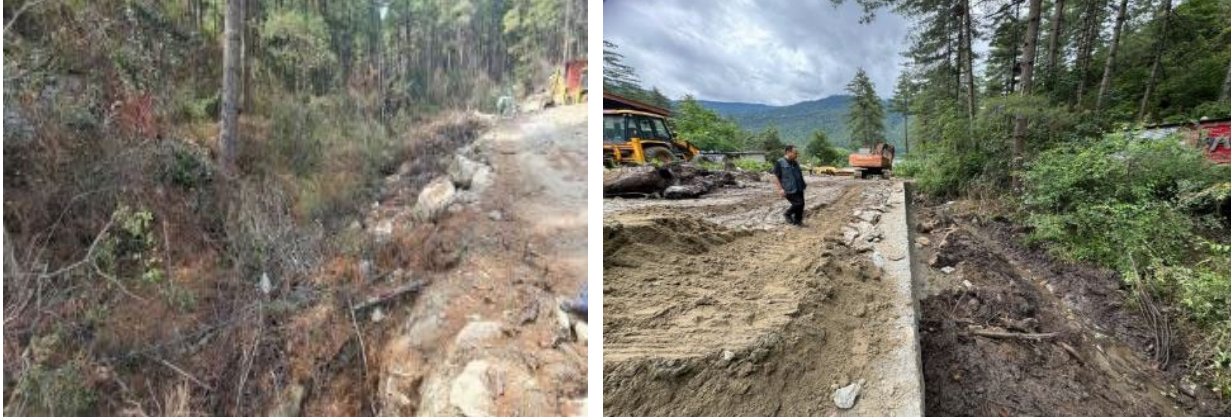
**Photo 10 a and b - Clogged Drain and Retaining wall constructed and Drainage cleaned**

43. During the tree felling and site clearance process, unwanted brush was dumped along the small stream flowing through the site, clogging it. However, the drain has since been cleaned, and a 40-meter-long retaining wall has been constructed to prevent stream bank erosion.

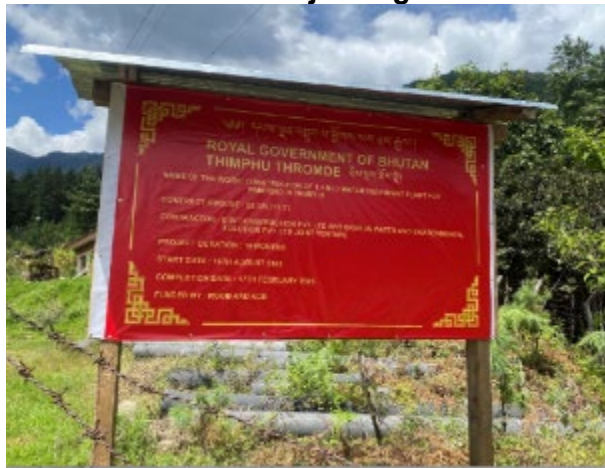
**Photo 11 - Project signboard**

44. The signboard has been installed and approved by Thromde. However, the contact details of the contractor have not been included on the signboard. The community has been informed about the WTP construction during public consultation (10 September 2023), wherein the contractor presented the details of the contract package.

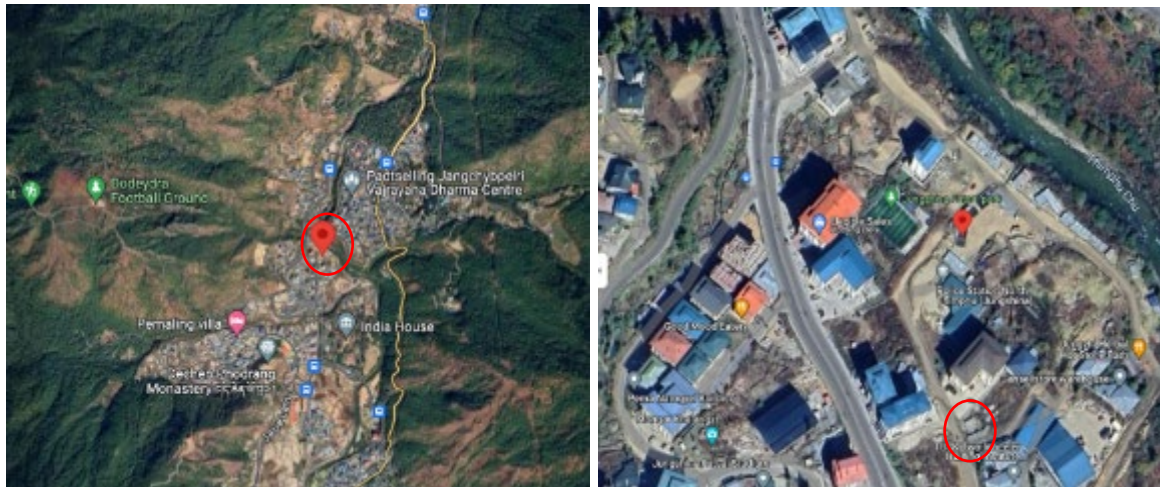
**Photo 14. CW-01 Site office and Camp site location**

61. Camps for site supervisors, drivers and workers are located in Jungshina, near the working site as approved by Thromde.

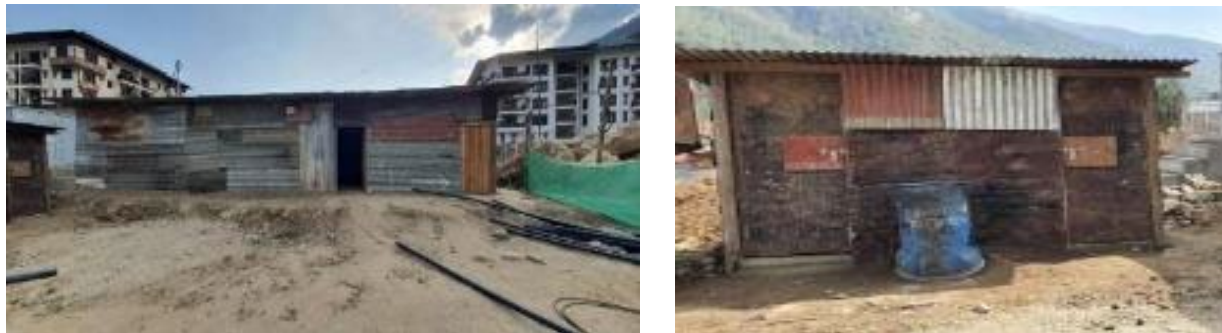
**Photo 15 a & b. Site office and toilet**

62. The site office, store and stockyard as well as machinery as located with the same premises.

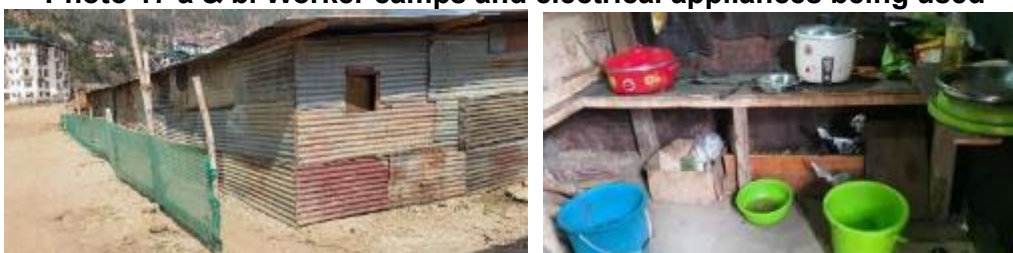
**Photo 17 a & b. Worker camps and electrical appliances being used**

64. Within the site, the site office, rooms for site supervisor and workers have been constructed. The camp houses 4 workers in each room. Sanitation facilities (with septic tanks) have also been provided. The worker camps are electrified but the electrical fixtures require rectification to ensure safety. No trees were cut to construct worker camps.

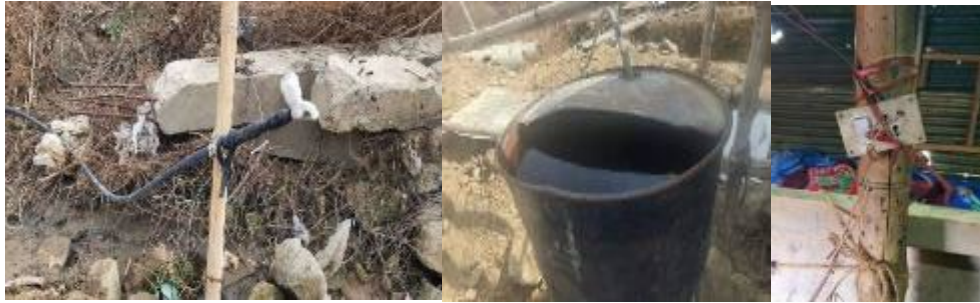
**Photo 19 a, b & c. Tapped drinking water plus water storage for toilets and Electrical fixtures**

65. Drinking water is sourced from the same source as all other users in Jungshina but this is not treated, and the water quality has not been tested.

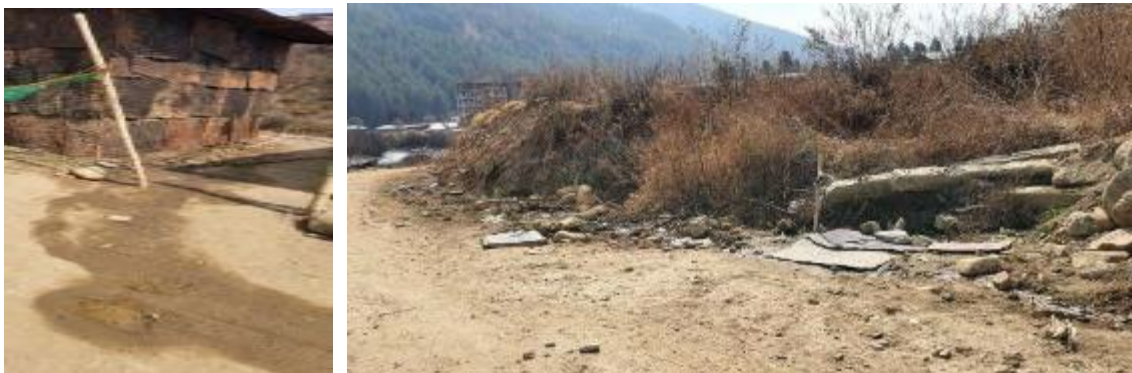
**Photo 20 a & b. Water flowing out of the worker camp (left) and the tap (right) onto the road**

66. No site drainage was observed at either of the worker camps. This is a problem especially for CW-01 site as the water from the tap flows into the untarred road. The problem is exacerbated because in the locality there is no municipal drain, to which the site drains can be connected.

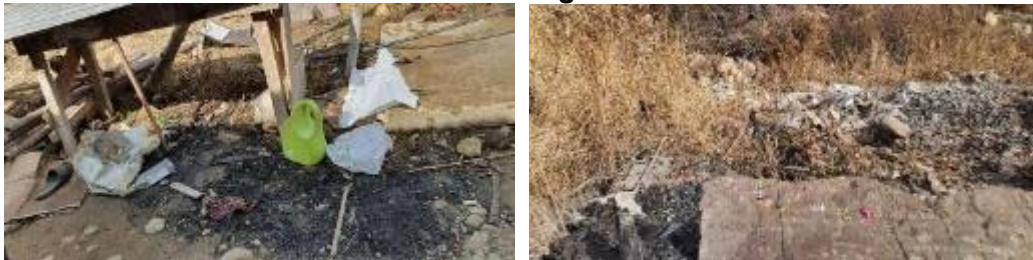
**Photo 21 a & b. Waste being burnt and discarded**

67. Despite being located within the collection area, waste management is not practiced in the site. There are no visible dustbins or waste segregation, and waste was observed being burnt and discarded downslope of the worker camps.

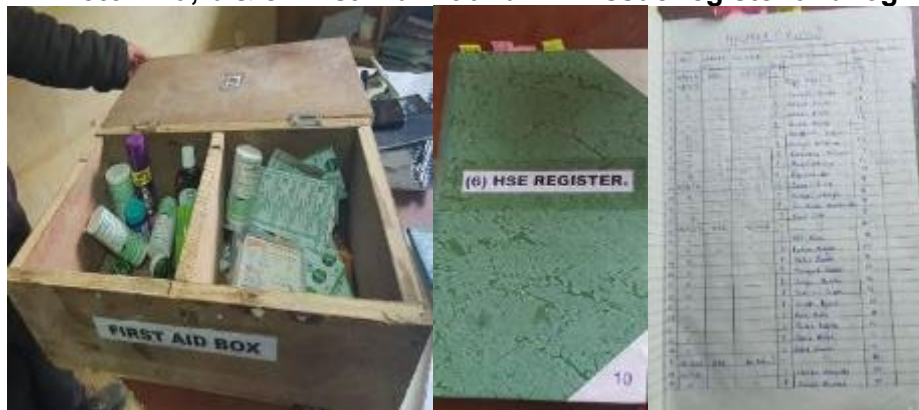
**Photo 22 a, b & c. First Aid Kit and PPE issue register and log**

- Worker health and safety plan submitted and approved (Appendix 6)
- Provision of PPE to workers
- First aid kit
- Emergency transportation to the hospital in case of emergencies

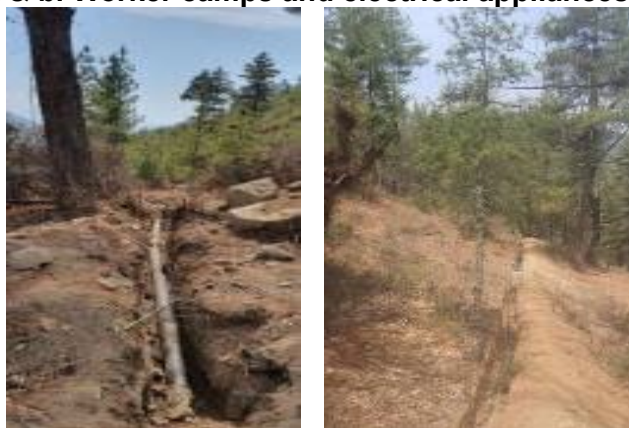
#### **Photo 24 a & b. Worker camps and electrical appliances being used**

74. The earlier survey required a forestry permit to cut 30 trees along the pipeline from Jungshina to Dechhencholing sites. However, due to careful pipeline laying, no trees needed to be cut. Similarly, no trees were cut to construct worker camps.

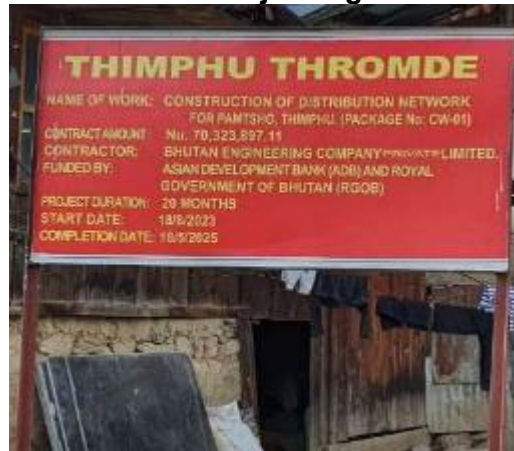
**Photo 25. Project signboard**

75. The signboard has been installed and approved by Thromde. However, the contact details of the contractor have not been included on the signboard. The community has been informed about the WTP construction during public consultation (10 September 2023), wherein the contractor presented the details of the contract package.

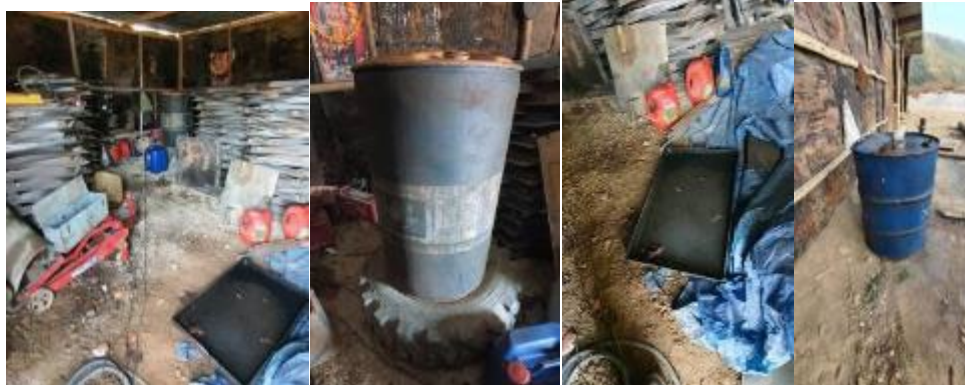
**Photo 26 a, b & c. Storage of diesel, collection tray and drum**

77. One drum of diesel is stored in the storage shed by the CW-01 contractor. Plastic tarpaulin and drip tray is being used for lubricants and used lubricant is stored in a drum outside the shed, without an impermeable lining.

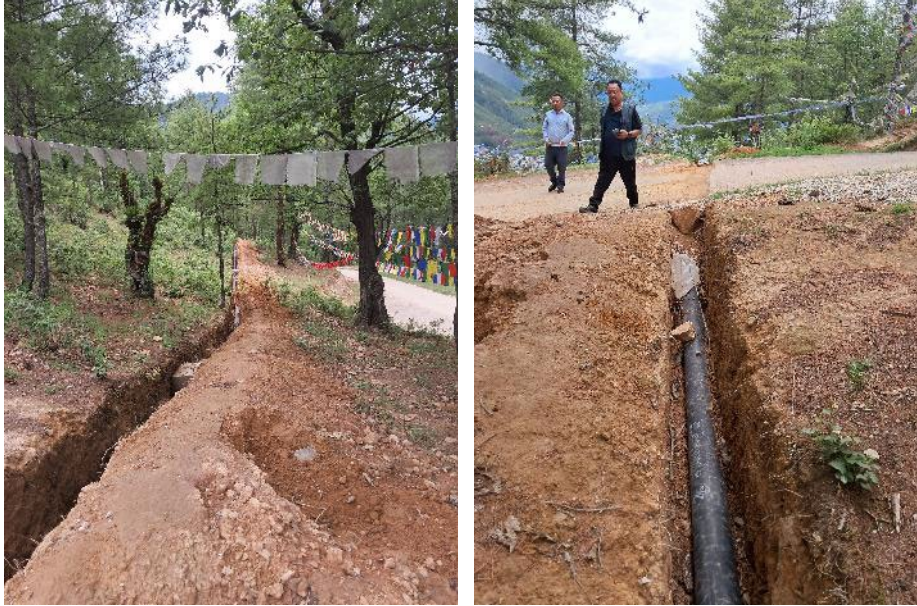
**Photo 27 a & b. Completed trenches in the forest above the highway to Dechhencholing**

alignment was moved from immediately above the road by at least 10-30 meters (depending on location) to avoid damaging the road.

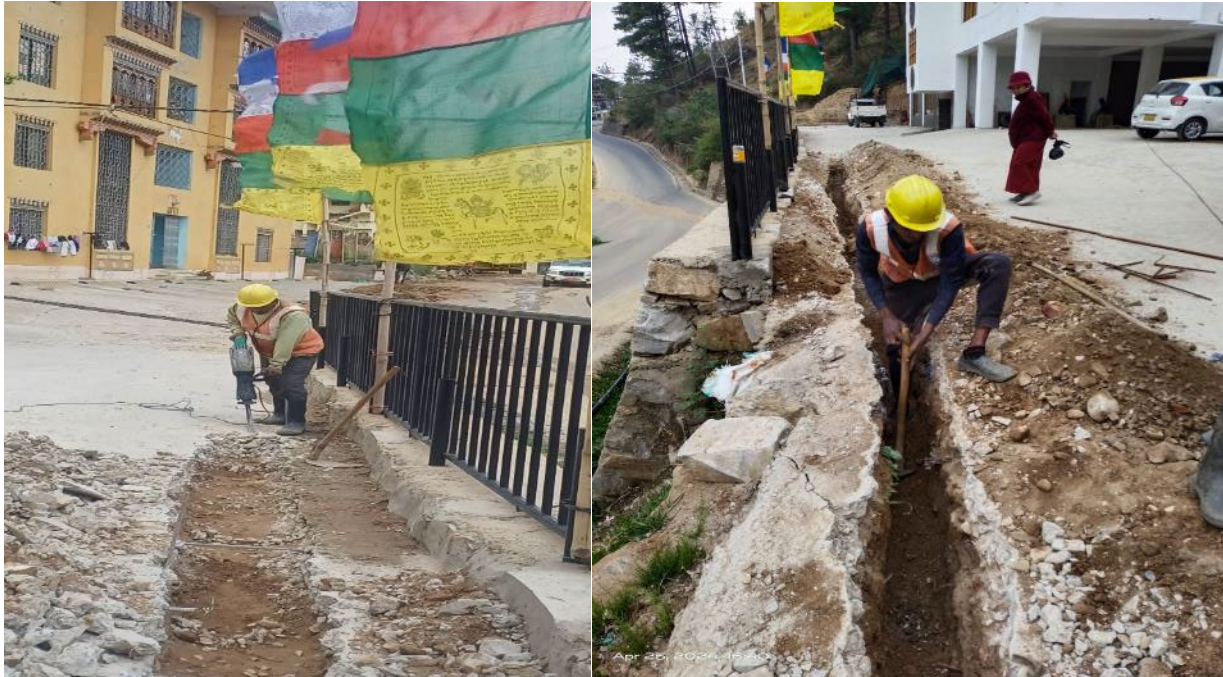
**Photo 29 a & b. Manual digging of trenches to minimize the damages private properties.**

81. On the other hand, for the smaller pipelines through the settlement areas, trenches are covered once pipelines are laid, especially at road crossings.

83. To avoid damaging the road as well as any existing structures and to minimize noise pollution, trenches are being dug manually.
