FINAL ACCIDENT INVESTIGATION REPORT

A5-BHT (EC130 T2 / H130, MSN:8160)

WACHEY- LUNANA, GASA, BHUTAN

03 MARCH 2023

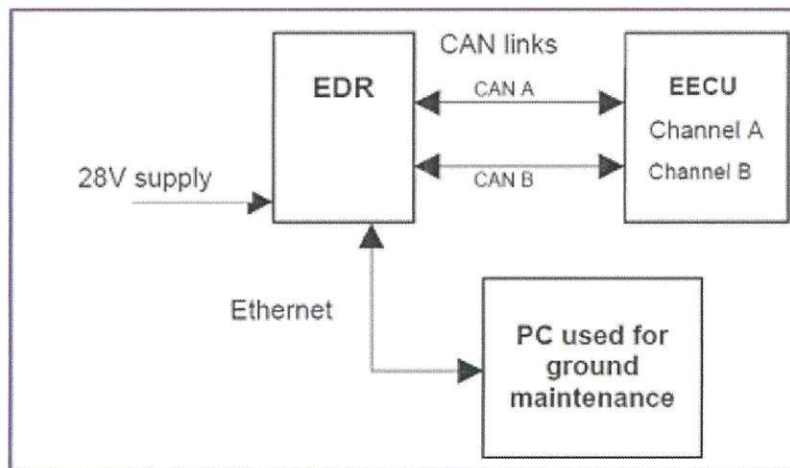
Fig 4. EDR (French BEA)

The EDR was visually examined and was found in good condition. Subsequently, decided to perform a direct readout with the manufacturer software. The readout generated the following dump file: *DUMP_ENG53048_9580119130_EDR03233_20230417_163607.dmp*. It was then converted to generate continuous and context recording file, failure flags file, engine power check file, overlimits file and errors file.

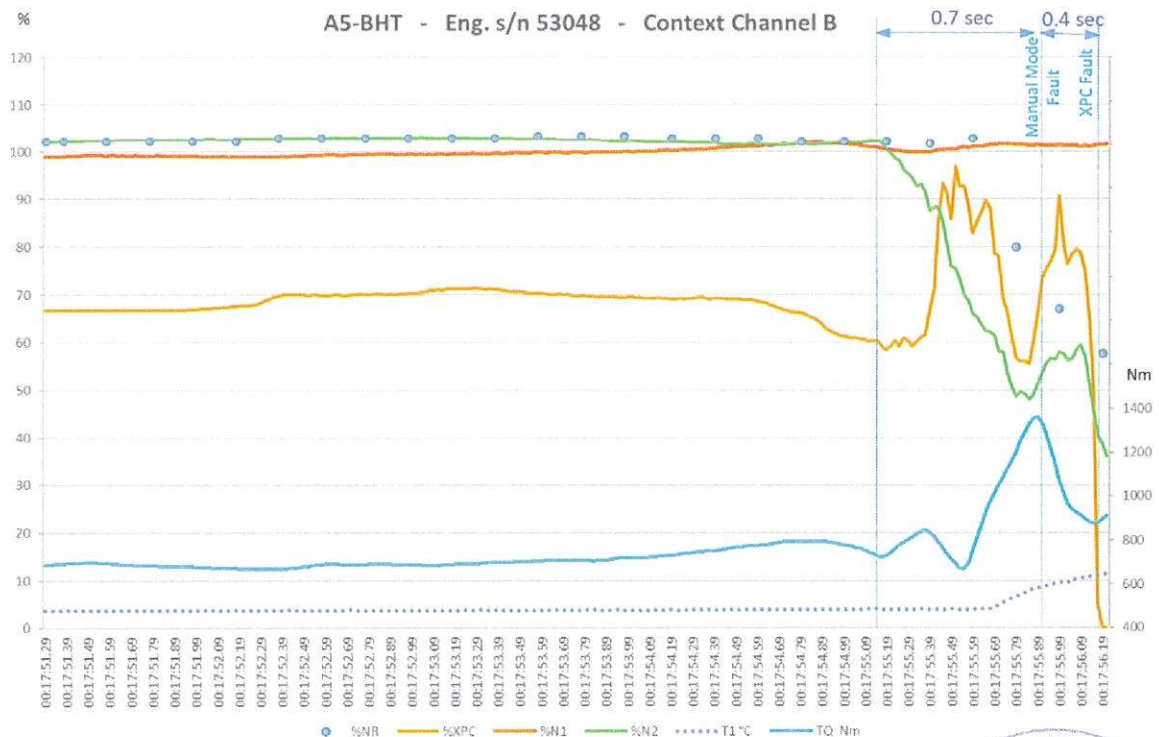
Fig 6. EDR context recording (Safran)

The channel B contained 5 seconds of context data which was analysed. The continuous recording stopped at 17 minutes 15 seconds (EDR time) and the context recording started from 17 minutes 51 seconds and stopped at 17 min 56 seconds. There is a gap of 36 seconds which are missing between the continuous recording and the context recording. The ECU sends the continuous recording every minute to the EDR for recording and the missing 36 seconds is consistent with the recording logic of the EDR.

All the engine parameters including the engine's fuel flow target (WF Cons) were nominal until the last 1.5 seconds of the recording. The turbine speed (N2) and main rotor speed (NR) reduced to about 48 % within 0.7 seconds during the final 1.5 seconds of the recording. Torque overlimit (reached a value of 138 daNm) was recorded at around 17 minutes 56 seconds and also collective pitch measurement (XPC) fault was noted within the last 1.5 seconds of the recording.

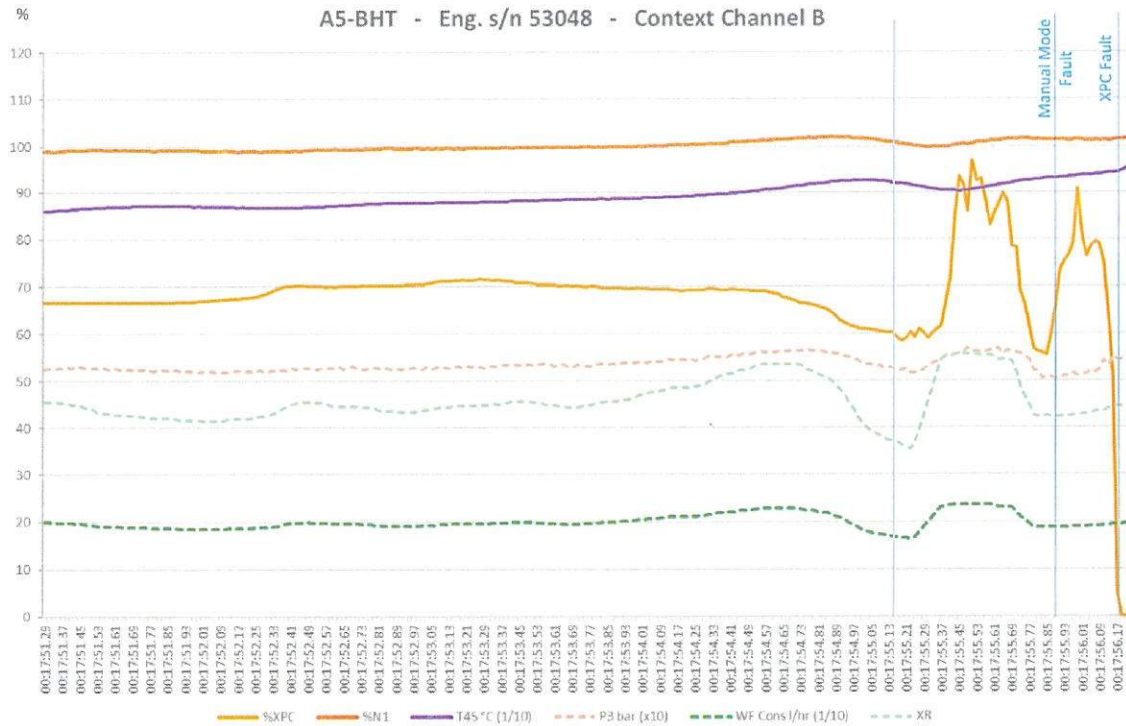
Fig 7. EDR context recording (Safran)

All the overlimits and discrepancies within the last 1.5 seconds were probably due to the consequence of the crash sequence. There were no faults and anomalies recorded throughout the entire flight except for the last 1.5 seconds of the recording. The failure of the collective pitch anticipator potentiometer (XPC) occurred most probably as a result of impact with the trees or ground. The helicopter was on the ground (or at least on the trees) when it recorded the torque overlimit and other overlimits in the final 1.5 seconds of the recording.

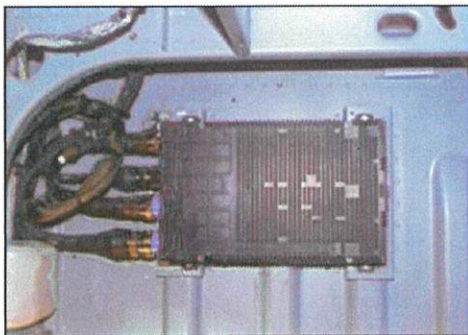
Fig 8. ECU (BEA)

The ECU was visually examined by the French BEA and was found in good condition. Since the data recorded in the EDR was fully recovered, no further work was performed on the ECU, as it would not contribute further insights to the investigation.

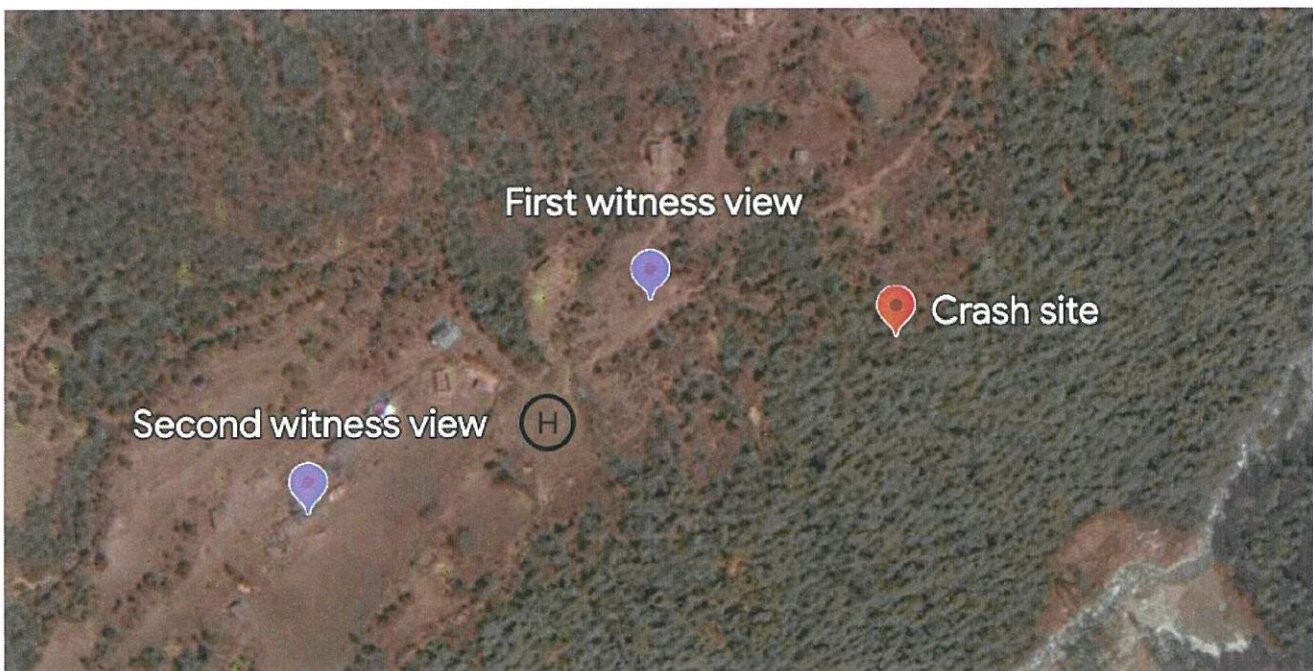
Fig 13. Witnesses view of the crash

There were two witnesses who observed the helicopter moments before the impact, although neither witnessed the actual crash, only heard it. The crash site, situated in a narrow ridge, was not within the line of sight for both the witnesses. The first witness had better view of the helicopter during the approach, yet the final impact point remained outside his line of sight. From their combined accounts, the helicopter approached from the south-west as usual towards the landing site. The helicopter approached at a low altitude and continued towards north-east before making a steep left turn. Both the witnesses had seen the helicopter gradually descend among the trees, tilted to the left, before making a soft thumping sound. Although

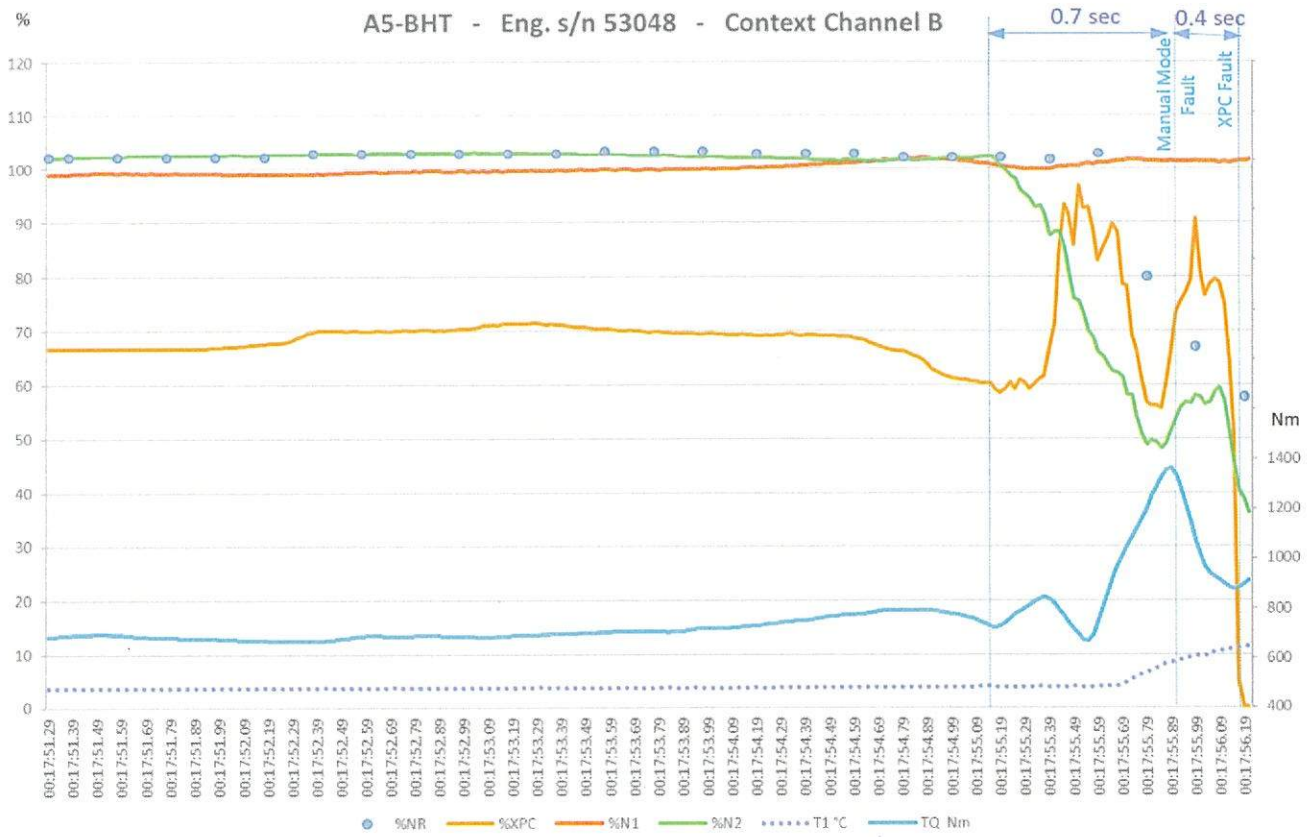
Fig 15. Context recording (Safran)

During the first 3.5 seconds there was a good synchronicity between the pilot's power demand (collective lever signal XPC) and the engine's fuel flow target (WF cons). There were variations in the fuel flow (WF cons) as well as fuel control system's actuator (XR) in the last 1.5 seconds of the recording, which led to fuel flow changes in the combustion chamber as seen in the combustion chamber pressure (P3) and the turbine temperature (T45). The fuel

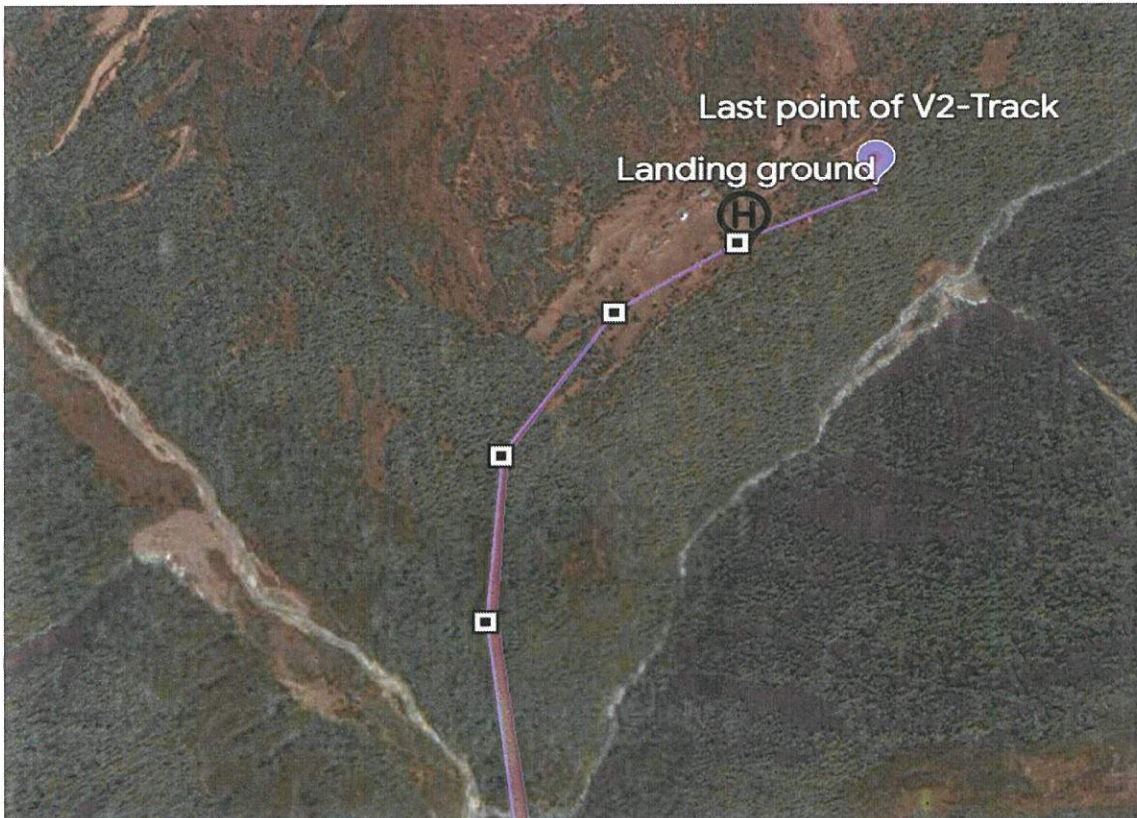
Fig 22. Accident flight path recovered

A total of 13 missing data points has been recovered. There were no anomalies observed regarding the V2-Track flight trajectory. The flight path of the helicopter has been recovered until few seconds before the crash as seen from the last point of the V2-Track.

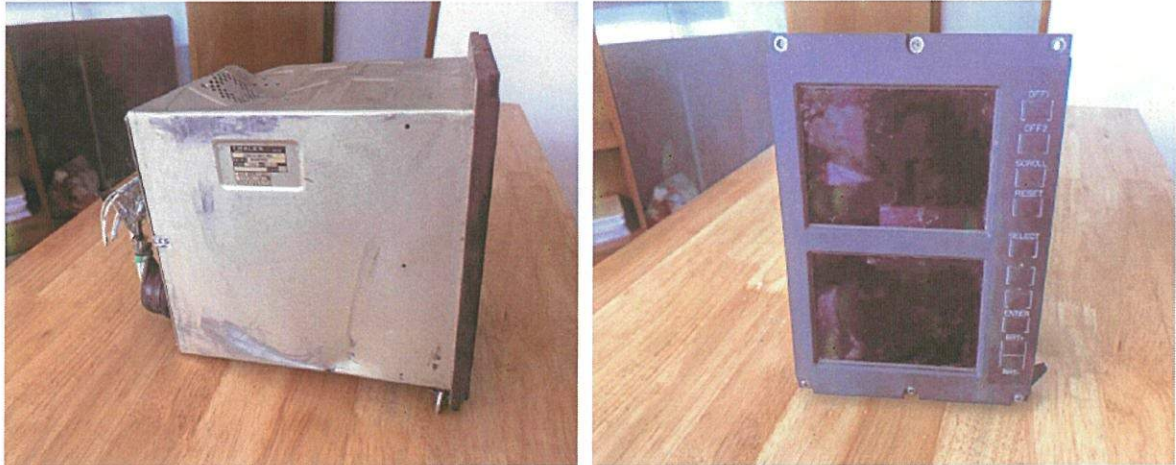
Fig 23. VEMD

The VEMD was visually examined and found damaged. It was crushed on the back and the top of the casing. The screen was in good condition. Since EDR data was fully recovered, no further work was performed on the VEMD as it wouldn't bring anymore insights for the investigation.
