Flood Management Plan for Haa Dzongkhag

*Strengthening Risk Information for Disaster
Resilience in Bhutan (RIR) Project*

INFRASTRUCTURE PLANNING AND FLOOD ADAPTATION DIVISION
DEPARTMENT OF HUMAN SETTLEMENT
MINISTRY OF INFRASTRUCTURE AND TRANSPORT
ROYAL GOVERNMENT OF BHUTAN

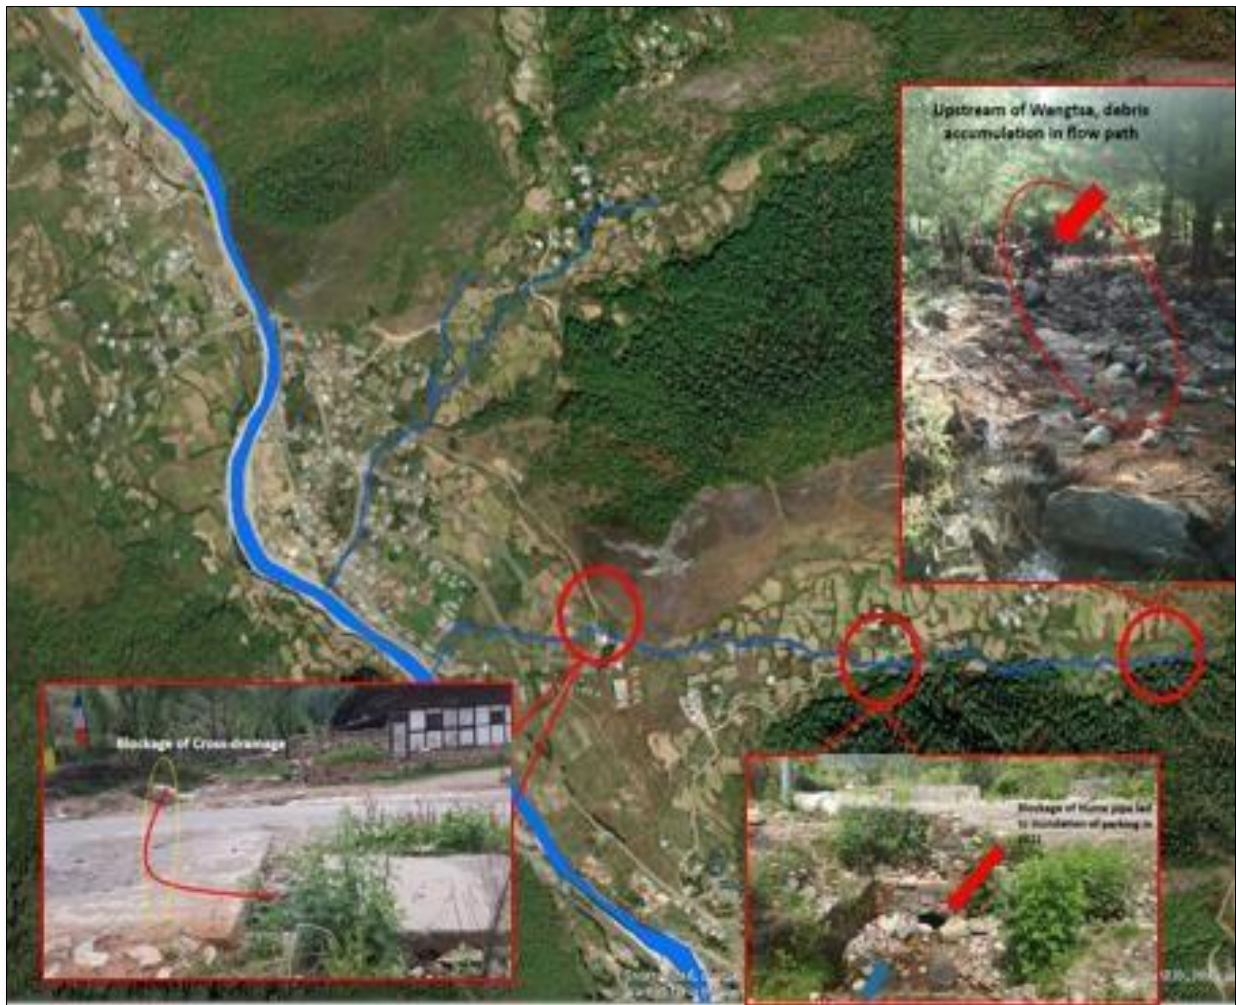
Figure 8: Critical Area along Wangtsa

Three streams were assessed for potential flood risk in Katsho, based on site investigation. Wangtsa chu indicated some critical locations in its flow path. The flow path has been restricted to a drain size at the crossing near the Dantak truck parking. Thereafter, the natural channel is converted to a storm drainage as shown in Figure 8.

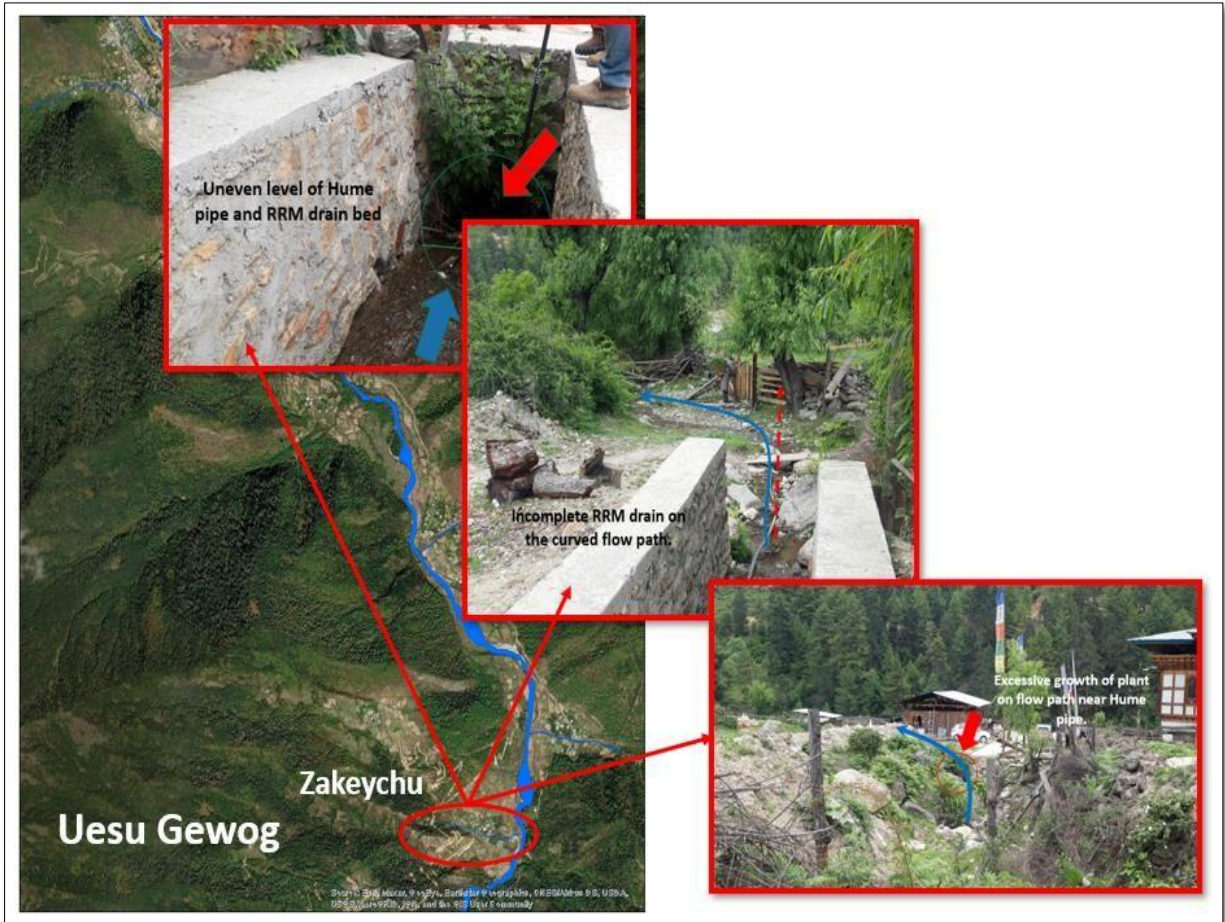
Figure 9: Critical Area along Zakeychu

The RCC drain along Zakeychu was observed to be critical as it obstructed the flow path near the settlement with no defined flow path as shown in Figure 9

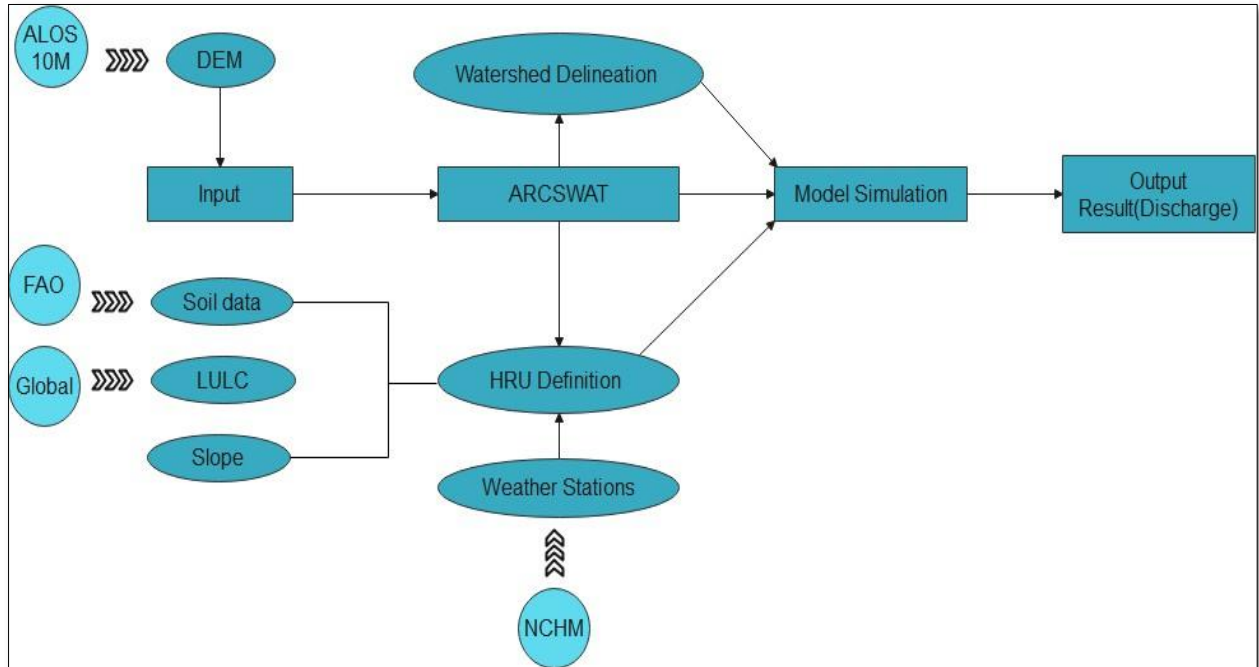
Figure 18: SWAT Model Flow chart

The SWAT hydrological model was built in a GIS environment, and the software used was ArcSWAT 2012 in ArcGIS version 10.4. Five sequential steps have been followed to set up the SWAT model, which are watershed delineation, HRU definition, weather data definition, edit SWAT inputs, and simulation. A detailed description of each of the steps has been articulated in Figure 18.

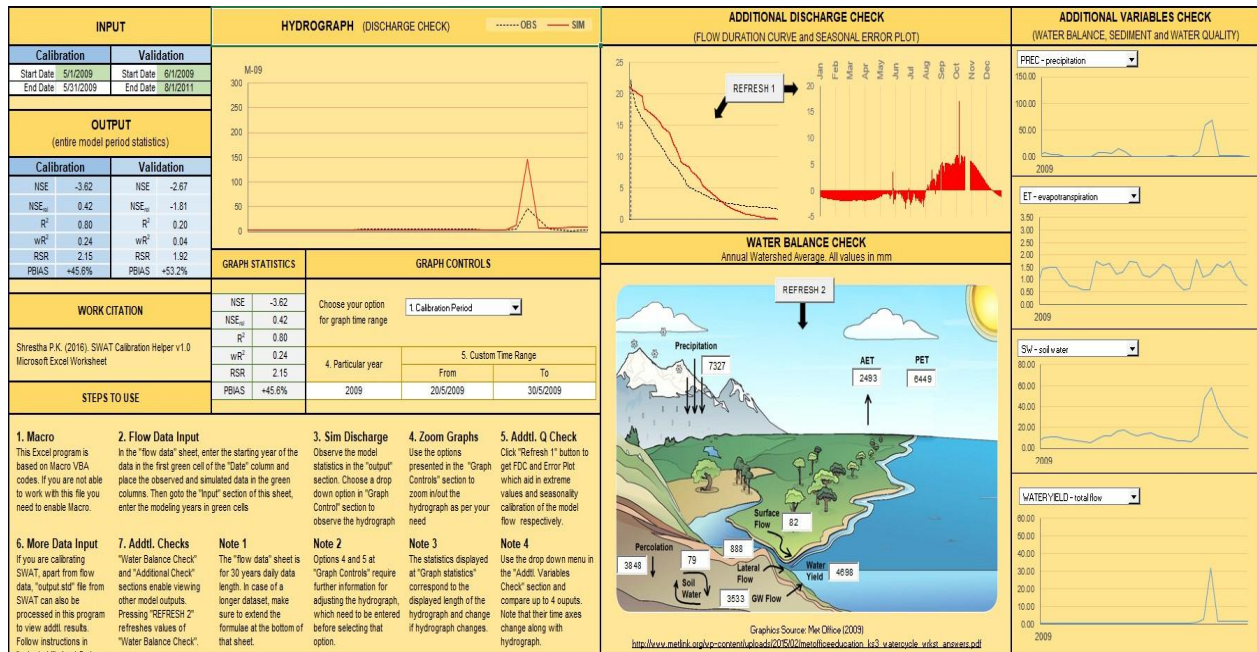
Figure 21: SWAT Calibration Helper v1.0

The discharge data available from Haachu flow station covers the period from 2000-2021. The calibration was tried using SWAT Calibration Helper v1.0 Microsoft Excel Worksheet developed by Shrestha P.K. (2016), shown in Figure 21.

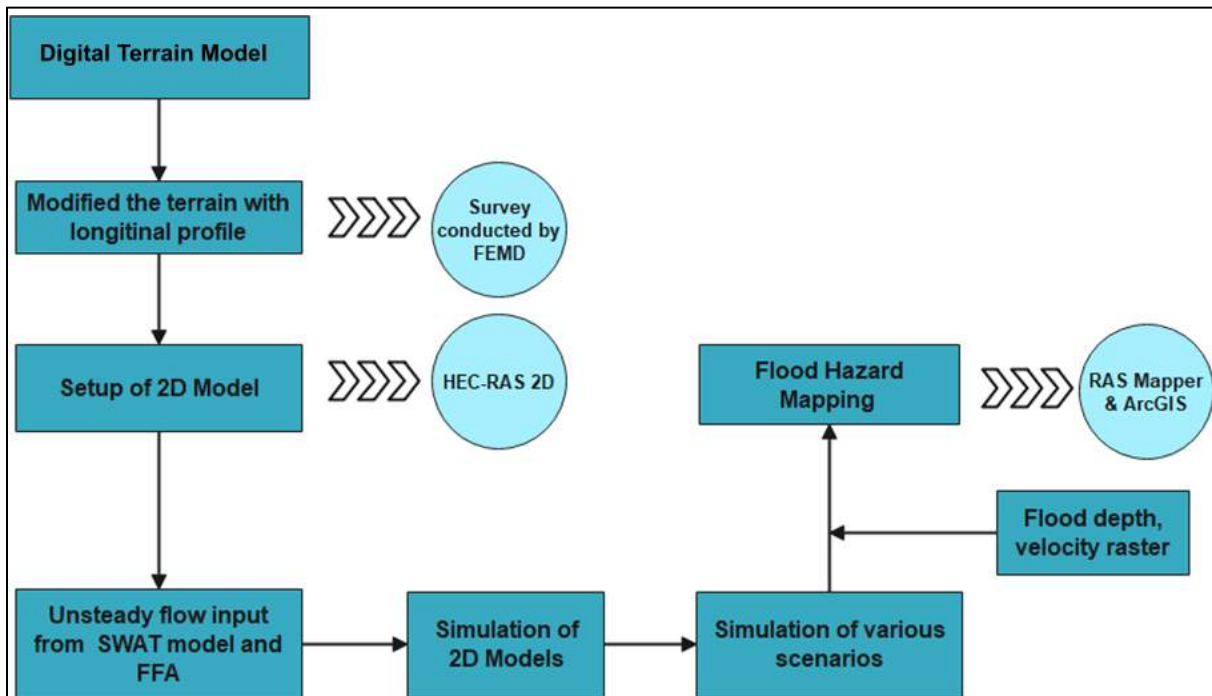
Figure 22: Methodology adopted for developing the 2D Hydrodynamic Model

The hydrodynamic model for the main river and the streams was developed, and a suitable 1D or 2D model was chosen for each area, as per data availability and results from the models. The following flowchart in Figure 22 shows the methodology adopted for developing HEC-RAS hydrodynamic models.
